# Manhole Inspection Summary

Manhole # **S19K\_\_014MH**

Insp Date: **8/10/09 11:43 AM**

**Location** Address: **2001 W PRATT ST**

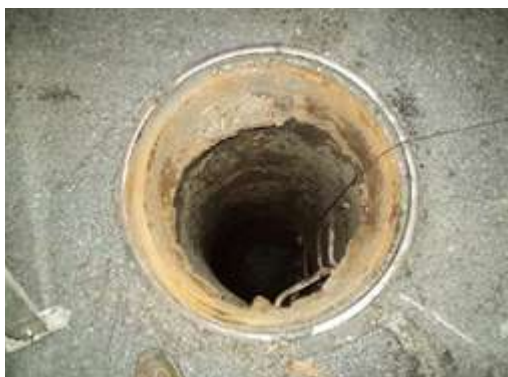
Defect 1

frame offset and corroded steps

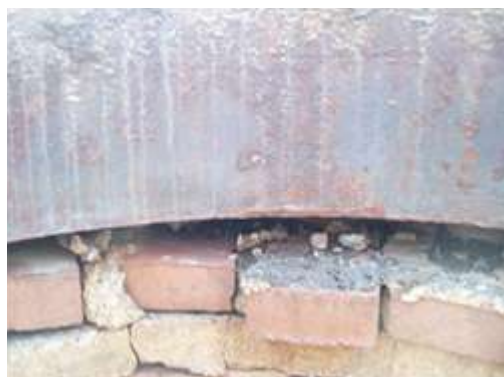
Defect 4

Condition: ☐ Sound ☐ Cracked ☐ Root Intrusion ☒ **Loose Brick** ☐ Deteriorated

LOOSE BRICKS ON CHIMNEY

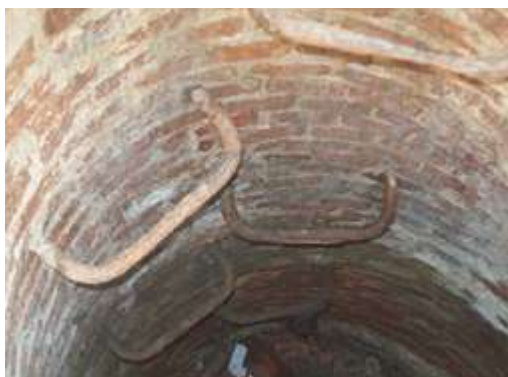
Defect 3

Count: **6** Missing: **0** ☒ **Corroded**

CORRODED STEPS

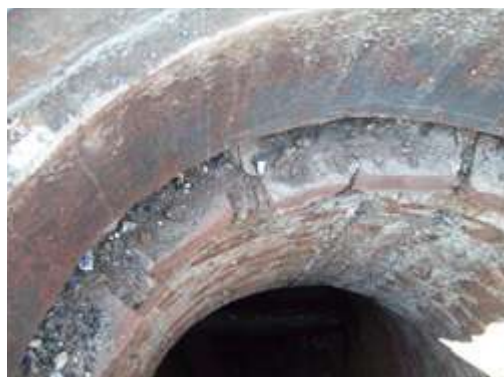
Defect 2

Offset: **2** (in.)

2" OFF SET FRAME

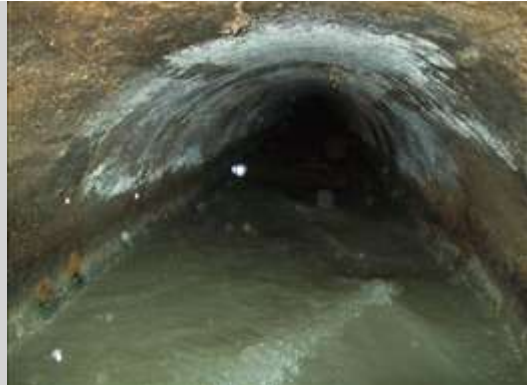
12 O'Clock Outflow

42 in. Circular Gravity Sewer  
Pipe Out @ 12 O'Clock

Pipe Height: (in.) Direct  
Pipe Material: **Clay** ☐ Pipe Lined  
Invert Depth: **10.90** (ft.) Flow Characteristics: **Slow**  
Deposits: ☒ None ☐ Mud ☐ Sludge ☐ Debris ☐ Grease  
Silt Depth: (in.) Deposits Extent:  
Infiltration: **None** Pipe Seal Cond: **Sound**

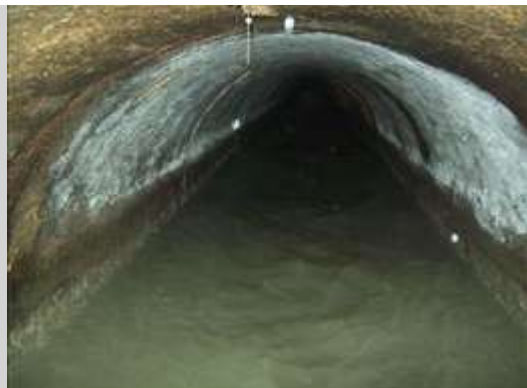
6 O'Clock Inflow

42 in. Circular Gravity Sewer  
Pipe In @ 6 O'Clock

Pipe Height: (in.) Direct  
Pipe Material: **Clay** ☐ Pipe Lined  
Invert Depth: **10.28** (ft.) Flow Characteristics: **Slow**  
Deposits: ☒ None ☐ Mud ☐ Sludge ☐ Debris ☐ Grease  
Silt Depth: (in.) Deposits Extent:  
Infiltration: **None** Pipe Seal Cond: **Sound**

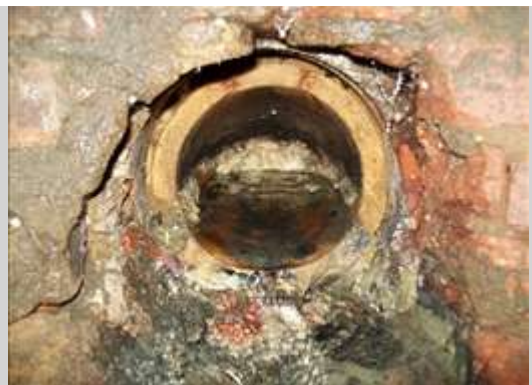
9 O'Clock Inflow

8 in. Circular Gravity Sewer  
Pipe In @ 9 O'Clock

Infiltration: **None** Pipe Seal Cond: **Sound**
